지역난방 시스템의 열 수송 기반 시설 내 HDPE 관 파손 분석

Failure Analysis of High-density Polyethylene Pipe in Heat-transport Infrastructure of District Heating System

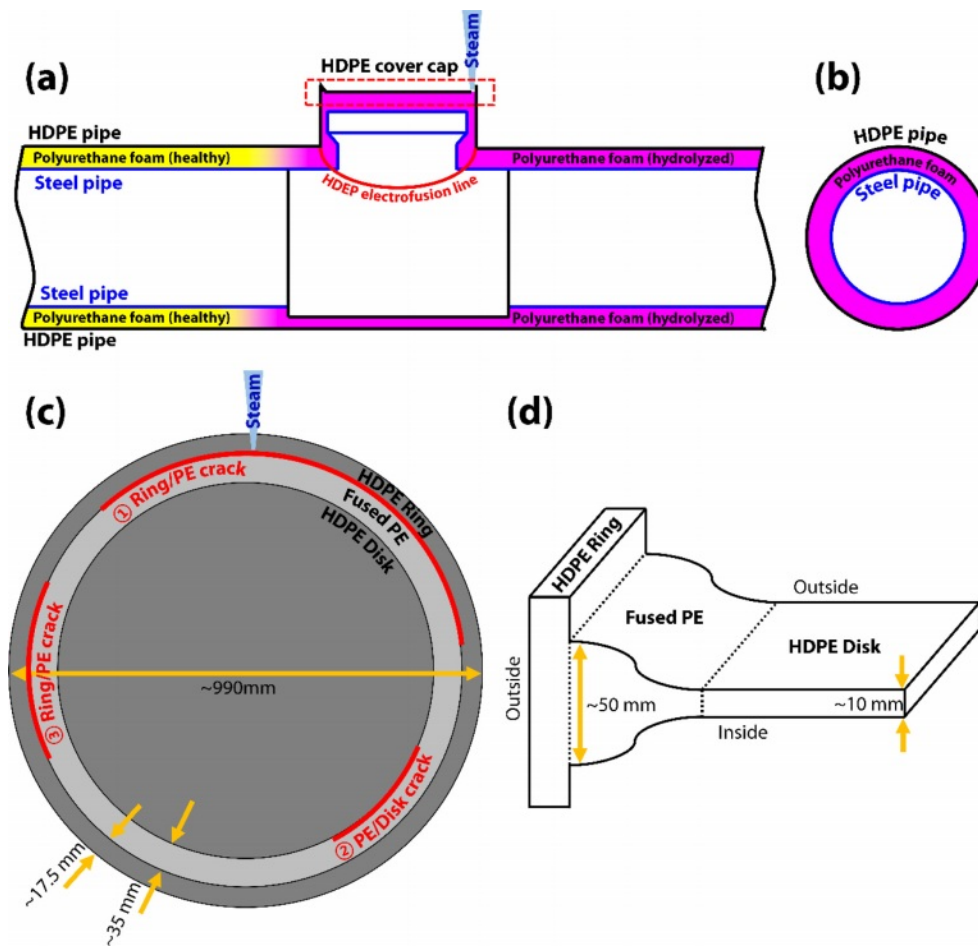
Figure 1. (a, b) Cross-sectional structures of heat-transport infrastructure with HDPE cover cap showing steam leakage; (c) structure of HDPE cover cap with crack positions; (d) its cross-sectional structure.

damaged HDPE cover cap was found due to steam leakage from the ground, where partially hydrolyzed polyurethane foam insulation was found (Figure 1(a)). Although the steel pipe was not fractured, the hot water of 100 – 115 °C in the steel pipe caused water from the external environment to vaporize and leak through the major crack in the HDPE cover cap. Since the location of this failure is adjacent to a river, the heat-transport pipe can be easily exposed to water. This study analyzes the failure of the HDPE component and identifies the reasons for the failure to establish a criterion for the soundness of the HDPE component. The findings of this study can be helpful in developing effective countermeasures for preventing future failures of the HDPE cover cap.

heat-transport infrastructure is an HDPE cover cap, as indicated by the red dashed-line rectangle in Figure 1(a). The diameter of the HDPE cover cap is approximately 990 mm, and it is composed of an HDPE ring with a width of ~17.5 mm, fused PE with a width of 35 mm, and an HDPE Disk with a thickness of 10 mm (Figures 1(c), (d)). The joint lengths in the thickness direction of the Fused PE with the HDPE Ring and the Disk are approximately ~50 mm (HDPE Ring side) and ~10 mm (HDPE disk side), respectively (Figure 1(d)). The failed HDPE cover cap exhibited three main cracks, which were located at the interfaces between the ring and fused PE (cracks 1, 2), and the fused PE and the Disk (crack 3) (Figure 1(c)). Since crack 1 was considered critical damage due to

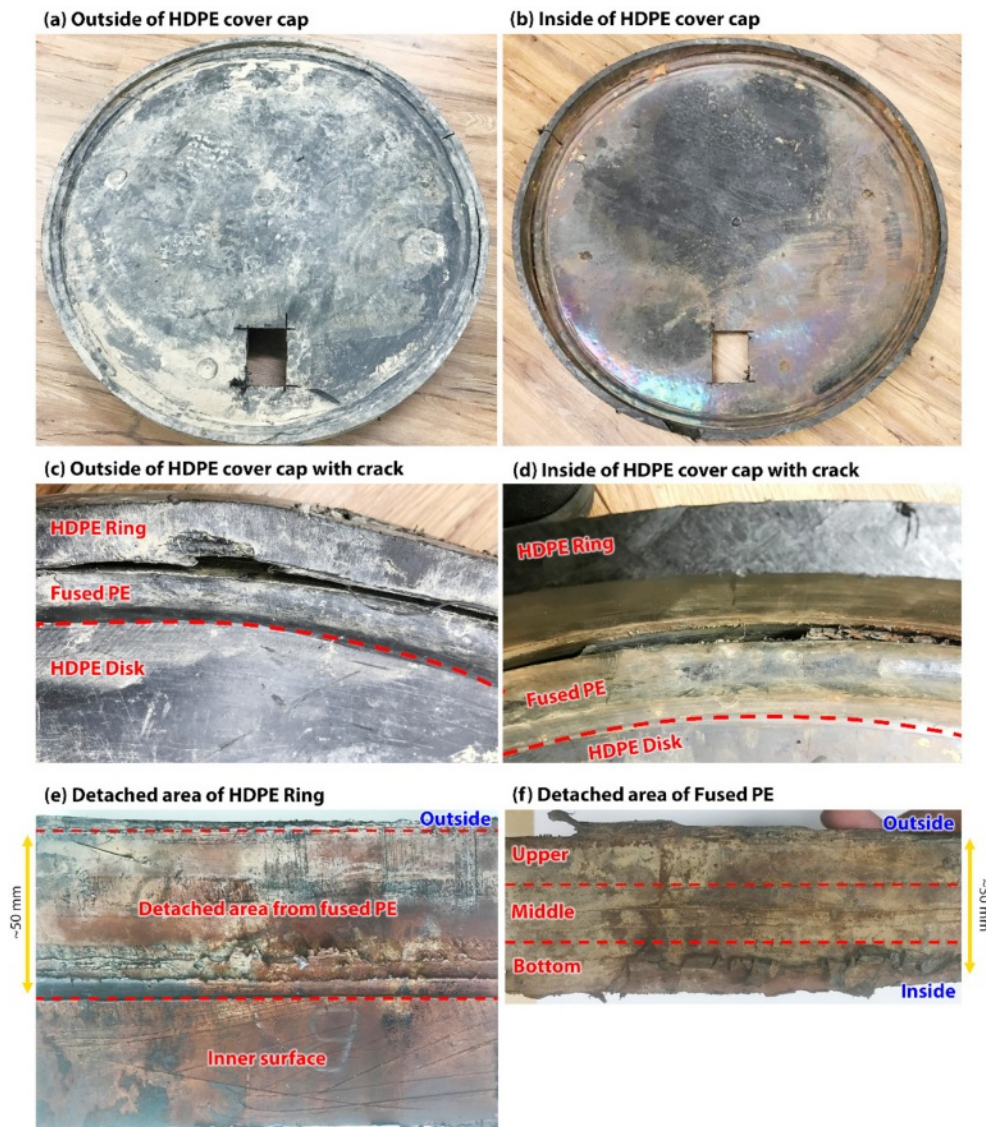
Figure 2. Outside, inside, and detailed views of the failed HDPE cover cap: (a) outside; (b) inside of the cover cap; (c) outside; (d) inside views of detachment between each component, and the detached surfaces; (e) HDPE Ring; (f) fused PE.

Visual Inspection. The outside and inside views of the failed HDPE cover cap are presented in Figures 2(a) and (b), respectively. The outside surface of the cover cap was contaminated with earth and sand due to its location buried in the ground, and scales were deposited on the inner surface. Crack 1 was located at the clockwise 11-3 position (steam direction: clockwise 12), while crack 2 and crack 3 were located at the clockwise 5 and 9 positions, respectively (Figure 1(c)). Crack 1 was visible on both the outside and inside of the HDPE cover cap, indicating that it allowed foreign substances to enter from the external environment to the interior of the HDPE pipe (Figures 2(c) and (d)). In contrast to Figure 2(c), Figure 2(d) shows PE debris on the fused PE between the HDPE ring and fused PE. To observe the detached area of the HDPE ring and fused PE, a portion of the cover cap was machined, as shown in Figures 2(e) and (f). The area of the HDPE ring glued to the fused PE was indicated by red dash lines (Figure 2(e)). The detached area was found to be heavily contaminated with foreign substances such as earth and sand, indicating prolonged exposure to contamination. PE debris similar to that seen in Figure 2(d) was also observed in the detached area of the HDPE ring and the fused PE.

An EDS analysis was performed on the detached areas of the HDPE ring and fused PE to investigate the substances that infiltrated the HDPE pipe through the main crack. A red-colored contaminant was observed on the detached area of the HDPE

ring (Figure 2(e)), which was identified to be iron oxide (Table 1). Iron ions dissolved from the steel pipe might have flowed out and into the HDPE pipe, and subsequently deposited on the inner surface as hematite. Other elements found in the contaminant may have originated from the surrounding soil.^{22,23} To examine the contamination tendency in the detached area of the Fused PE, the region was divided into three sections (upper, middle, and bottom) and analyzed using EDS (Figure 2(f)). The results showed that while iron was detected in higher concentrations in the bottom region, the upper region also exhibited higher concentrations of aluminum and silicon (Table 2). These findings are consistent with the results of visual inspection, which indicated that both internal and external substances had been flowing out and in, respectively, via the crack for an extended period of time.

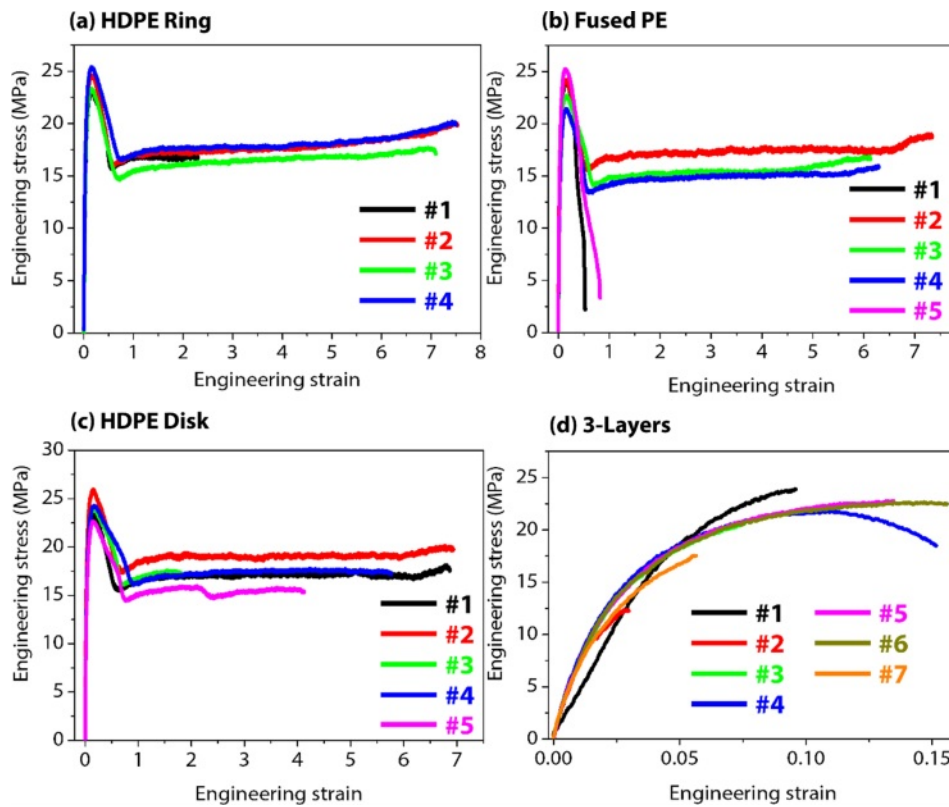
Figure 3. Tensile responses of (a) HDPE ring; (b) fused PE; (c) HDPE disk; (d) 3-layers machined from the HDPE cover cap.

the number of tensile samples (#n) indicates the number of tests for reproducibility. The stress-strain curves for each component displayed typical five-step tensile behaviors consisting of elastic deformation, necking (strain softening), cold drawing, strain hardening, and failure.^{24,25} Although the distinction between the cold drawing and strain hardening steps was not clear, they appeared to occur simultaneously in a mixed state. The HDPE ring exhibited a distinct stress drop after reaching an average tensile strength of 24.1 MPa, followed by typical elongation behavior of a soft material with further strain. This component then fractured at a strain of 610.5% (since the tensile strength is identical to the yield strength, both strengths

were denoted as tensile strength). The average tensile strength of the five fused PE specimens was 23.5 MPa (Figure 3(b)). While #1 and #5 failed immediately after necking with a rapid stress drop without undergoing the cold drawing step, #2-4 were strained until reaching an average strain of 658.7%, similar to the HDPE ring. Although all the tensile specimens were machined from inside the HDPE cover cap, pores were observed on specimens #1 and #5 (see Figures 4(a), (b)), unlike #2-4, which may have had a disadvantageous effect on their mechanical behavior. The HDPE disk exhibited similar tensile behavior to the Ring, with a tensile strength of 24.1 MPa and elongation of 510.2% (Figure 3(c)).

The results of the tensile tests for the 3-layers are presented in Figure 3(d) and Table 4. To avoid distortion induced by the effects of the cross-head direction, samples #1-4 and #5-7 were installed with the ring part and disk part facing the cross-head direction, respectively, and then pulled during the tensile test. Most of the specimens failed before necking, revealing an average maximum strength of 19.6 MPa. Excluding specimens #2 and #7, which exhibited the weakest strength, the maximum strength for the others averaged 21.6 MPa, which is approximately 90% of the tensile strength of the HDPE components. However, the elongation for the 3-Layers averaged only 10.1%, indicating significantly lower ductility. The degraded tensile properties can be interpreted from the fracture tendency and fractography. Figure 4(c) shows the 3-Layers samples that were

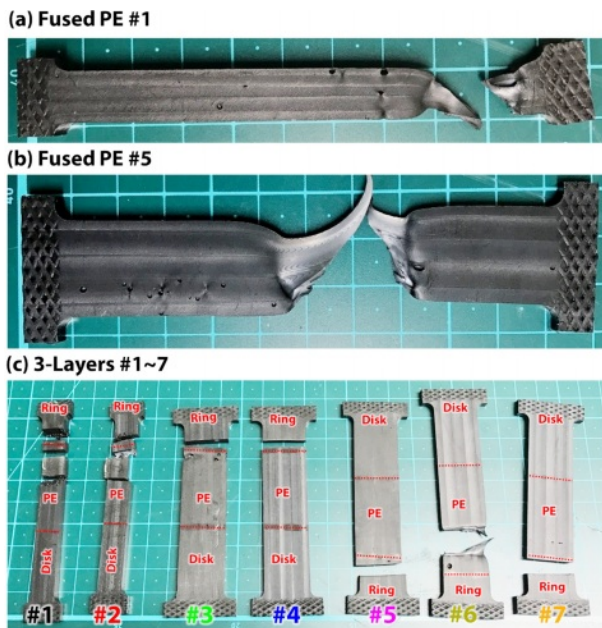
Figure 4. Fracture morphologies for (a) specimens #1; (b) #5 which are the fused PE samples; (c) specimens #1-7 which are 3-Layers samples.

subjected to the tensile test, with red dashed lines indicating each interface. Specimens #1, #2, and #6 failed with a brittle and ductile fracture mode in the fused PE part near the Ring part, displaying fracture debris induced by severe necking, similar to Fused PE specimen #5 (Figure 4(b)). In contrast, specimens #3-5 and #7 failed with a brittle fracture mode on the Ring/PE interface, showing a flat fracture surface. As observed in Figures 4(a) and (b), pores were also present in the fused PE (Figure 4(c)), and severe necking near pores were observed in specimen #3, indicating that the applied stress was concentrated on the area surrounding the pores. Obviously, pores can deteriorate the mechanical properties of the HDPE component. However, the observation of the fracture occurring on the Ring/PE interface rather than in the area surrounding the pores indicates that this interface is more vulnerable than the components and the PE/Disk interface.

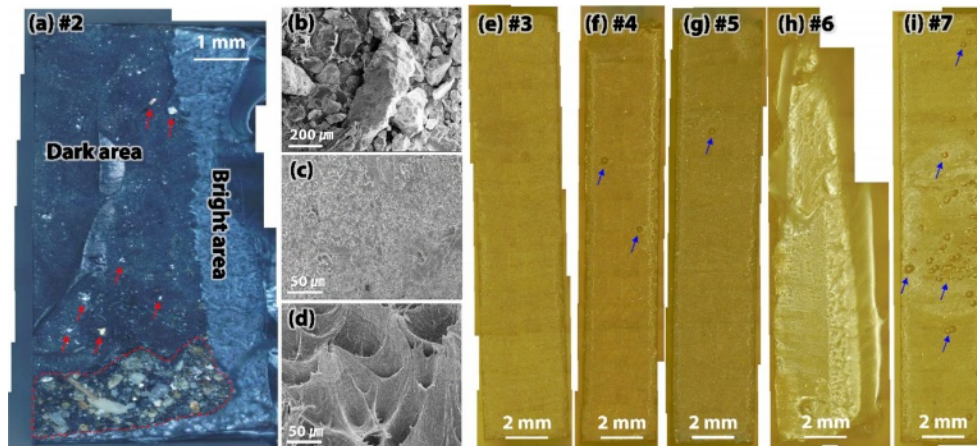
The fracture surface of 3-Layers sample #2 was analyzed to determine why it exhibited the lowest mechanical behavior with a maximum strength of 12.2 MPa and elongation of 3% (Figure 3(d), Table 4). The fracture surface contained foreign substances embedded in the material, with sizes ranging from 50-500 μm , indicated by red-dash lines and arrows in Figure 5(a). The EDS analysis revealed that these foreign substances were earth and sand, as indicated by the high content of carbon and the detection of sodium, aluminum, and silicon (Table 5).²³ Inflow of these foreign materials likely occurred during the manufacturing process, as it is difficult for foreign material to enter the material after installation of the HDPE cover cap. The fracture is believed to have initiated at the position where sand was embedded, and the crack propagated through the dark area in a brittle manner, leading to failure at the bright area in a ductile manner.^{8,25,26} Fracture behaviors can be observed in Figures 5(c) and (d), with smooth surfaces on the dark area and severe sheared dimples on the bright area, respectively. The existence of foreign substances and pores (blue arrows) with sizes rang-

Figure 5. Fracture surfaces of the tensile-tested 3-layers samples shown in Figure 4(c).

ing from 150–300 μm on fracture surfaces #4, #5, and #7, respectively, led to lower maximum strength and brittle fracture at the interface (Figures 5(f), (g), (i)). These results suggest that foreign substances and the number of pores are crucial factors that reduce tensile properties. Their presence reduces the cross-sectional area, causing stress concentration in these areas, which diminishes adhesion of the Fused PE and ultimately leads to degraded tensile properties.

Among the HDPE components, fused PE exhibited lower performance when it contained pores, and the ring/PE interface was found to be particularly vulnerable based on the results of the 3-layers test. This is attributed to the manufacturing characteristics of the HDPE cover cap. While the ring and disk components are produced by injection molding, the process for fused PE used for joining both components is carried out in an outdoor environment and is subject to rapid environmental changes, which can lead to the formation of interior pores and to contamination. Therefore, crack 1 (Figure 1(c)) was initiated from the ring/PE interface, where the Fused PE on the Ring-side showed low maximum strength and toughness, even with low impact. The ductile and brittle fracture behaviors displayed by the HDPE components and the 3-layers specimens revealed that the cracks rapidly propagated and thinly stretched failure debris was left after necking during fracture, indicating the direction of failure. While crack 1 showed a relatively flat surface on the outside of the detached surface, fracture debris remained on the inside (Figures 2(d)–(f)), indicating that the crack was initiated from the outside and propagated inward. In summary, cracks were generated from the outside of the ring/PE interface, diminished by pores and foreign substances, and propagated along the thickness direction. External force was concentrated on the fused PE, which is weaker than the interface, and the HDPE

Based on the analysis results, we propose the following countermeasures to prevent the failure of HDPE pipes and cover caps in heat-transport infrastructure. First, the manufacturing environment for HDPE components should be carefully controlled to minimize the generation of pores and foreign substances. Special attention should be given to optimizing manufacturing conditions when fusing the ring and disk by PE, as this process is particularly vulnerable to the generation of interior pores. Alternatively, electro-fusion could be employed, as it results in enhanced adhesion strength compared to fused PE. Second, after the cover cap is joined to the HDPE pipe, air pressure tests and external impact tests corresponding to 20 MPa in strength should be conducted to ensure the integrity of the components. Finally, we recommend that the mechanical performance results of each component and interface evaluated in this study should be utilized to predict the load limitations of HDPE pipes and cover caps in future designs. By implementing these measures, it will be possible to enhance the reliability and durability of HDPE components used in heat-transport infrastructure.
